DEVELOPMENTAL HALT REPORT
R-0000274

Product Tested: 600W power supply

Service Proposal #: S-0000274

Client(s): Vox Power Ltd
Terenure Enterprise Centre,
17 Rathfarnham Rd,
Dublin 6W,
Ireland

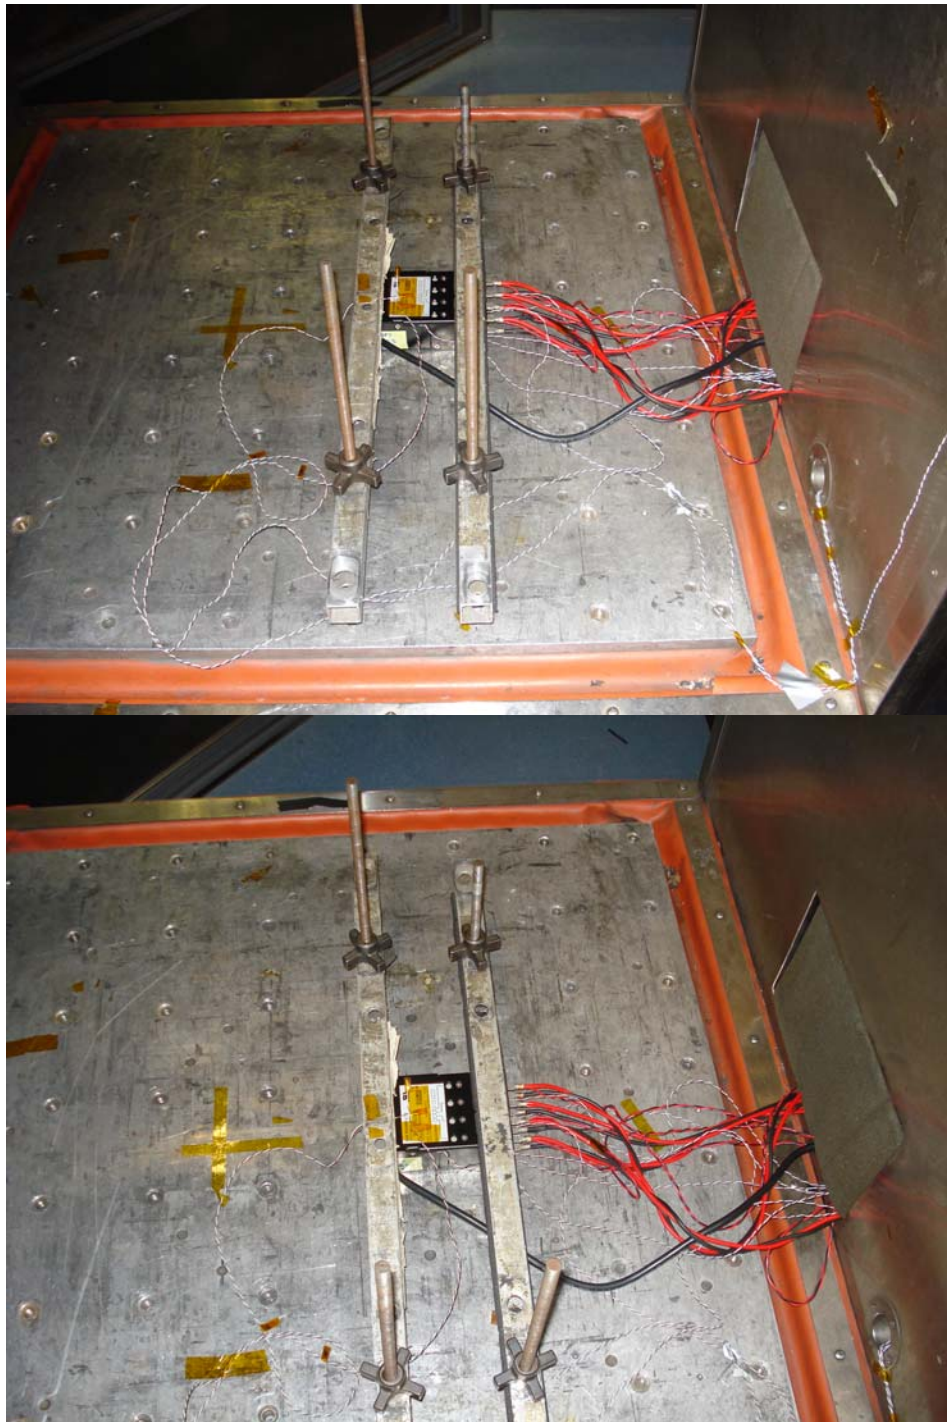
Figure 1 – Thermal and vibration Set-up

The product was tested one unit at a time. The product under test was secured using two bars of aluminium U-channel and all-thread to clamp the metal chassis to the vibration table. Air from the chamber plenum was directed onto the units. The fixture was designed to maximize both transmission of energy from the vibration table to the product and thermal transition rates, as well as to help maintain consistent temperatures on all the components inside the test units. Pictures illustrating the fixturing and arrangement of test units in the test chamber are presented in Appendix A.
